Field Report for Airborne Data Collected In Support of US EPA Region VI Valley Feed Mill Fire 25 September 2018

Background

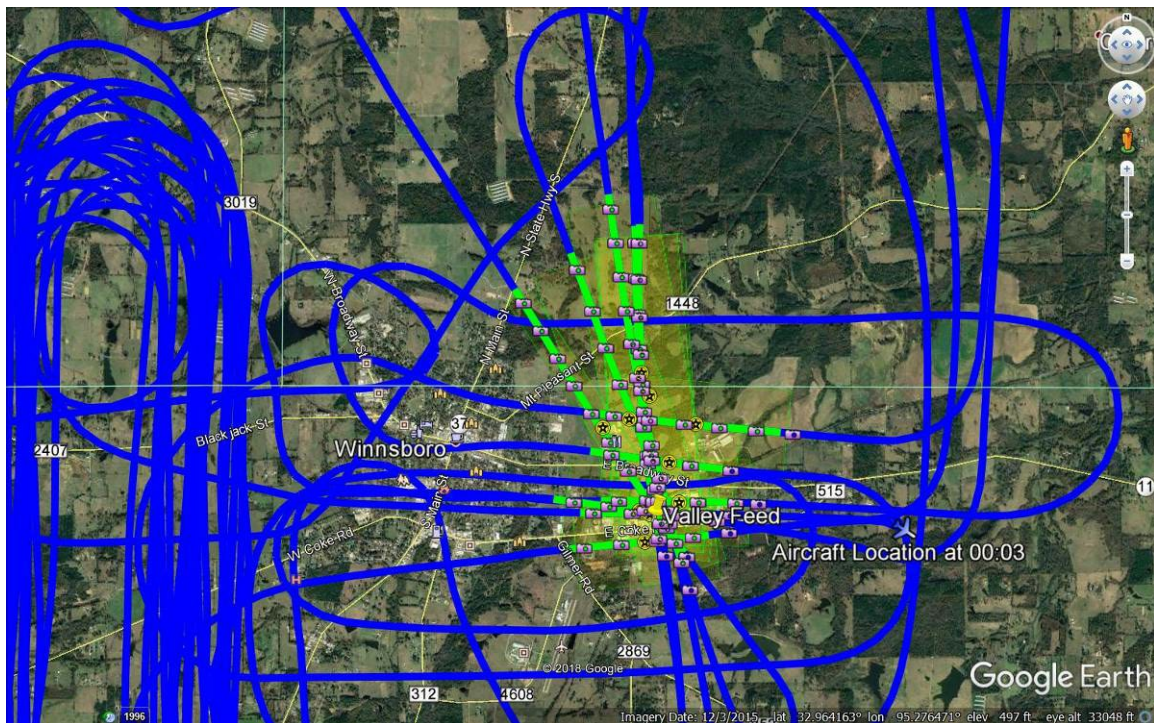
Figure 2: Data collection passes, Valley Feed Fire, Winnsboro, TX. The blue lines represent the ASPECT flight path, green lines represent when the Infrared Line Scanner was actively collecting data, and the camera icons represent when a photo was taken.

The order to launch the aircraft was given 1510 local on 25 September 2018 and the aircraft was airborne at 1600. The initial data collection run over the site was at 1633 (local) The aircraft made a total of 14 data collection passes; flight information is summarized in Appendix A and Figure 2.

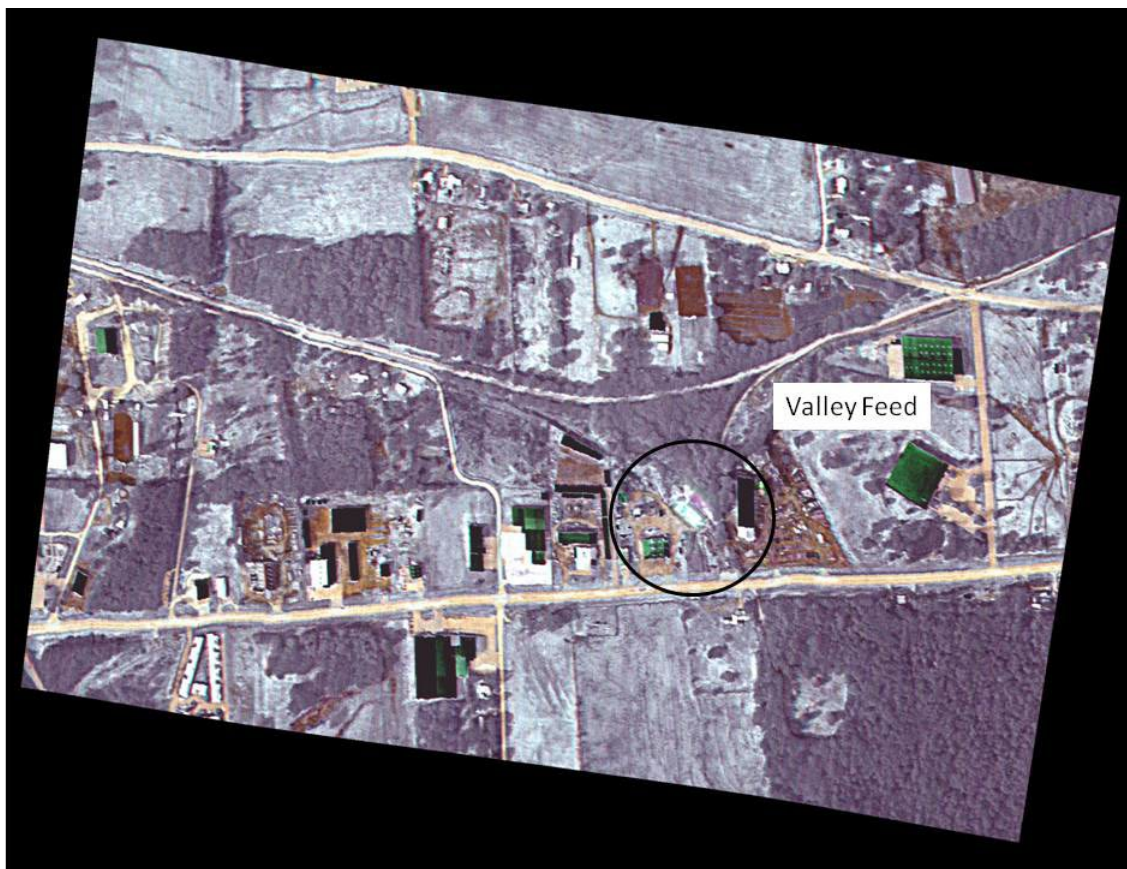
A total of 1 test and 13 data passes were made in the proximity of the site and an infrared line scanner images were generated for each pass. Figure 3 shows a typical 3-band infrared image obtained from data collected for Run 6. The highlighted area shows the location of the facility. Examination of the detail shows slightly elevated temperatures in relation to the surrounding area (white is hot). personnel had foamed the fire and greatly reduced the thermal signature of the fire. An IR plume was not observed on any of the collection flights.

Figure 3: – 3 band IR image, Run 6, Valley Feed

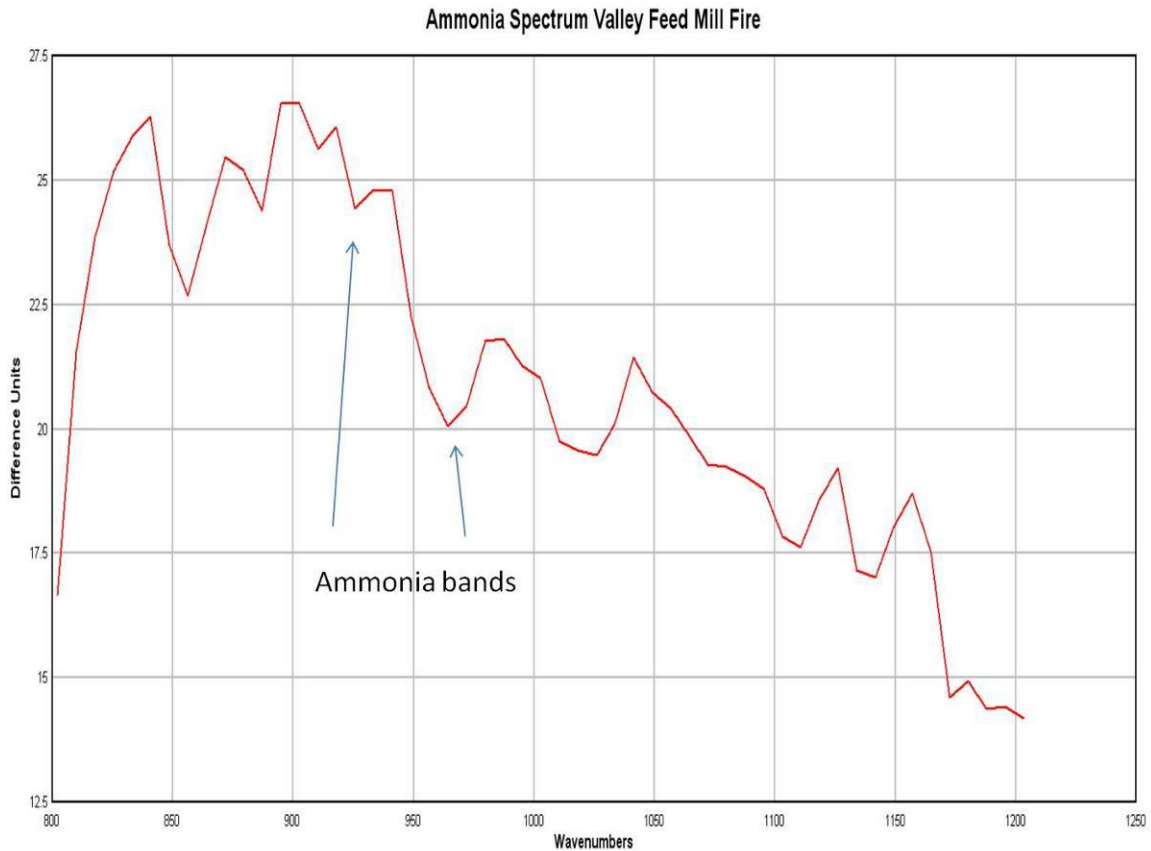
Ammonia was detected on this mission and the detection of 2.2 ppm was just above the detection limit for the system (figure 4 and table 3). Figure 5 shows the spectra of the detection with characteristic peak near 930 and 960 wavenumbers. The peak near 850 wavenumbers is CO₂. It should be noted that the apparent baseline shift of the data is

due to the passive nature of the data. The concentration reported by the system is likewise confirmed due to the low signal to noise ratio (approximately 3) of the data. The detection was made downwind of the fire as part of data run 5.

Figure 5: Ammonia Spectra, Run 5, Valley Feed Fire

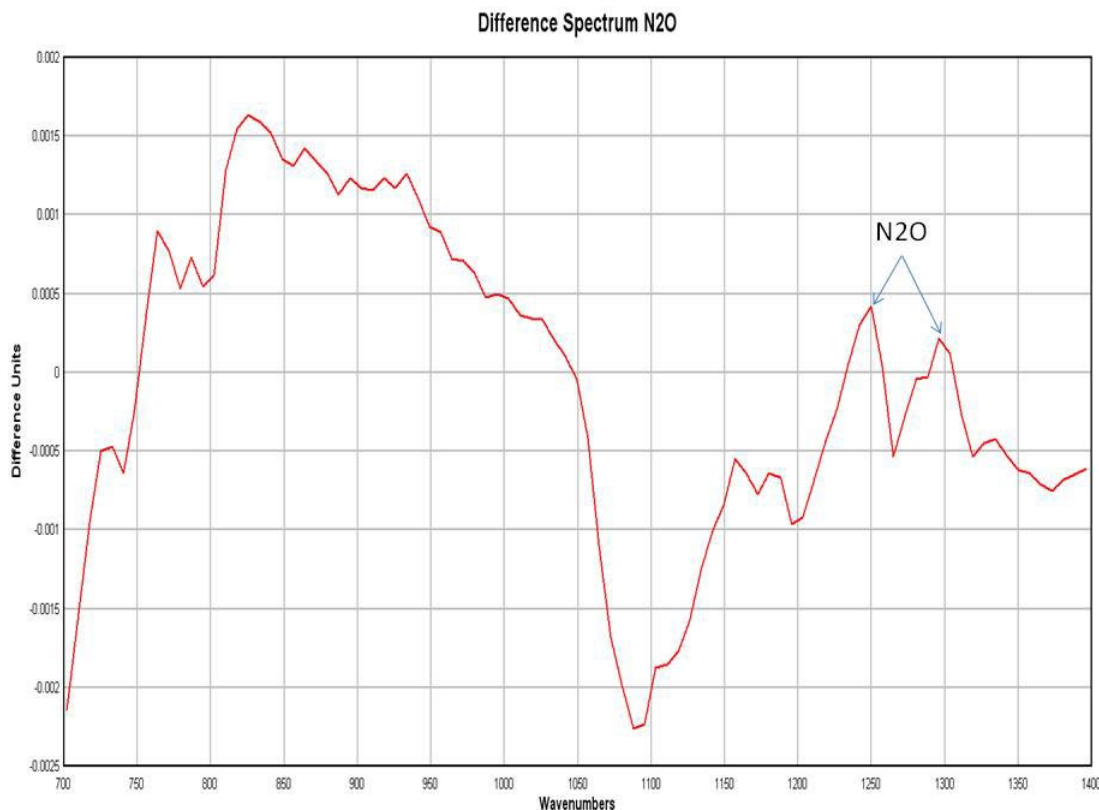
Manual analysis of the data showed the presence of low levels of Nitrous Oxide (N₂O) in passes near the fire (figure 6). N₂O has two peaks in the long wave region consisting of 1220 and 1280 wavenumbers. The large feature centered on 1080 wavenumbers is peroxyacetyl nitrate (PAN) a compound associated with the incomplete combustion of nitrogen rich materials. No other data passes showing detectable results for any other compounds.

Figure 6: Nitrous Oxide Spectra, Run 14, Valley Feed Fire

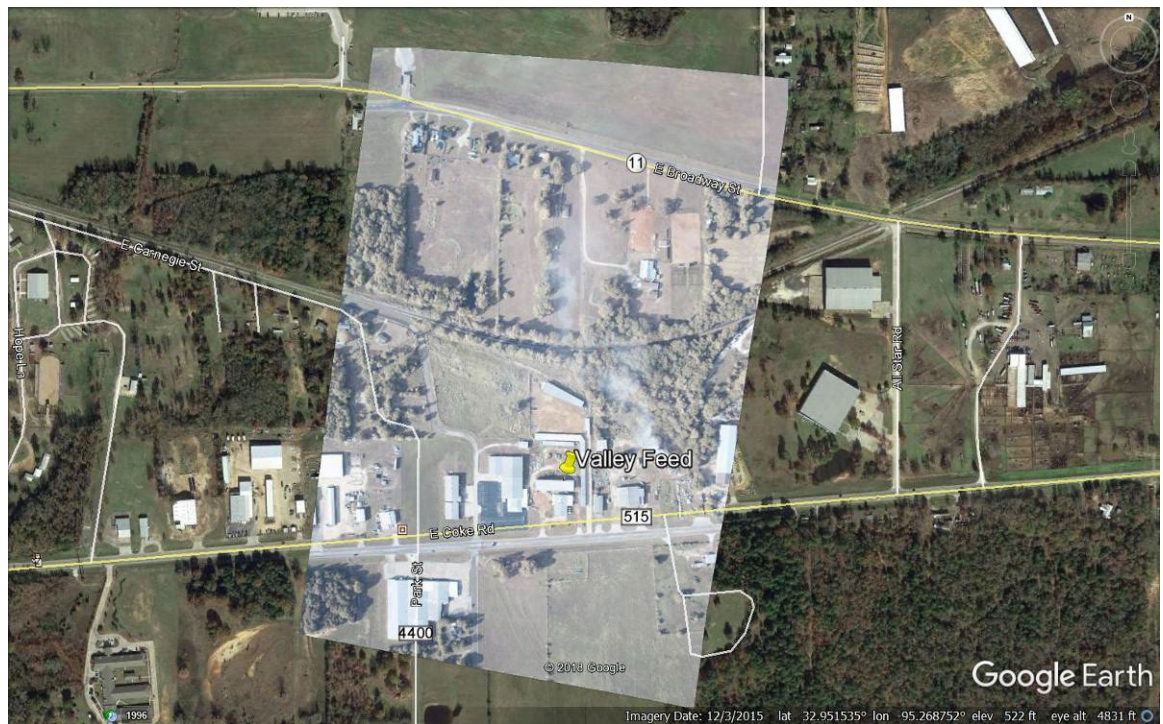
A full set of high resolution aerial digital photography were collected as part of the flight. Figure 7 shows a representative image collected as part of Run 6. This image has been ortho-rectified with the top of the image being north. Examination of the photo shows a faint white plume drifting toward the north. (It should be noted that ground reports show the plume as light yellow) The low opacity of the plume indicates that the facility fire is nearing the final phase.

Figure 7: Aerial image Valley Feed Fire

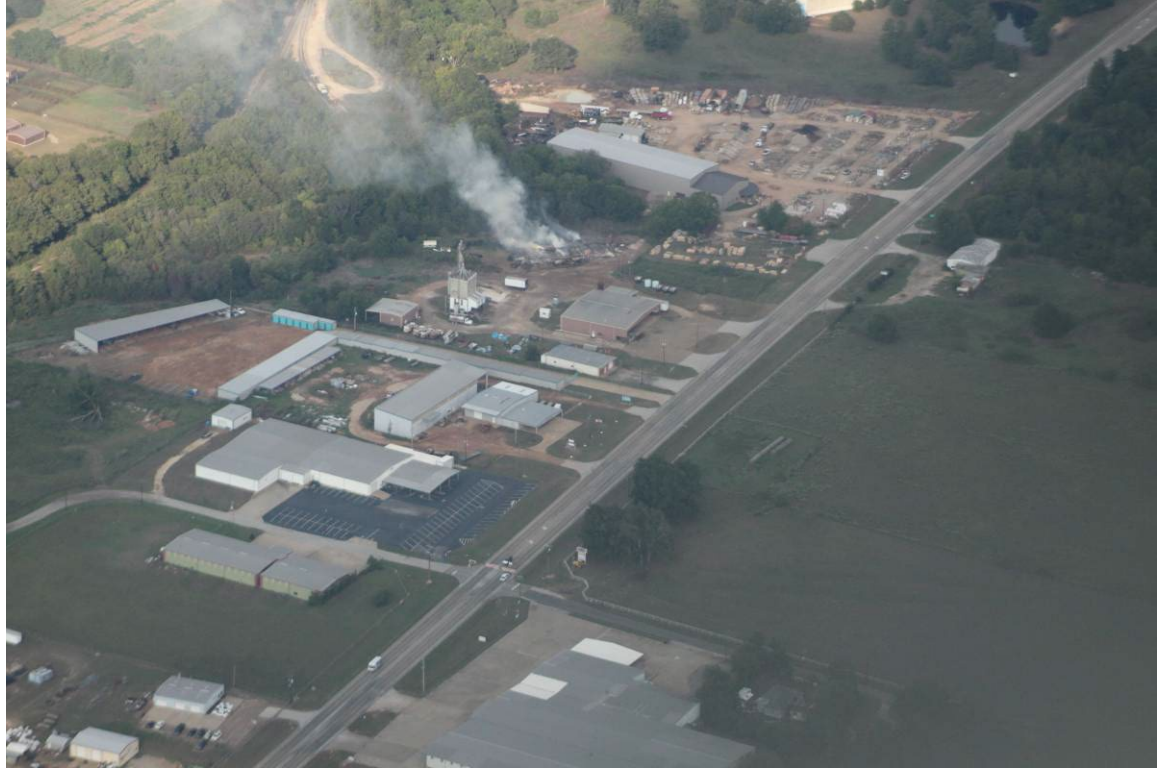
Figure 8 shows an example of an oblique image collected as part of the mission. This image was taken from the copilot station and is roughly looking to the northeast. A white and climbing plume is clearly evident in the image.

Figure 8: Oblique image Valley Feed Fire
